NRL/MR/6180--04-8742

Performance of Fire Protective Coatings Subjected to DC-ARM Wartime Scenario Fires Aboard Ex-USS *Shadwell*

January 16, 2004

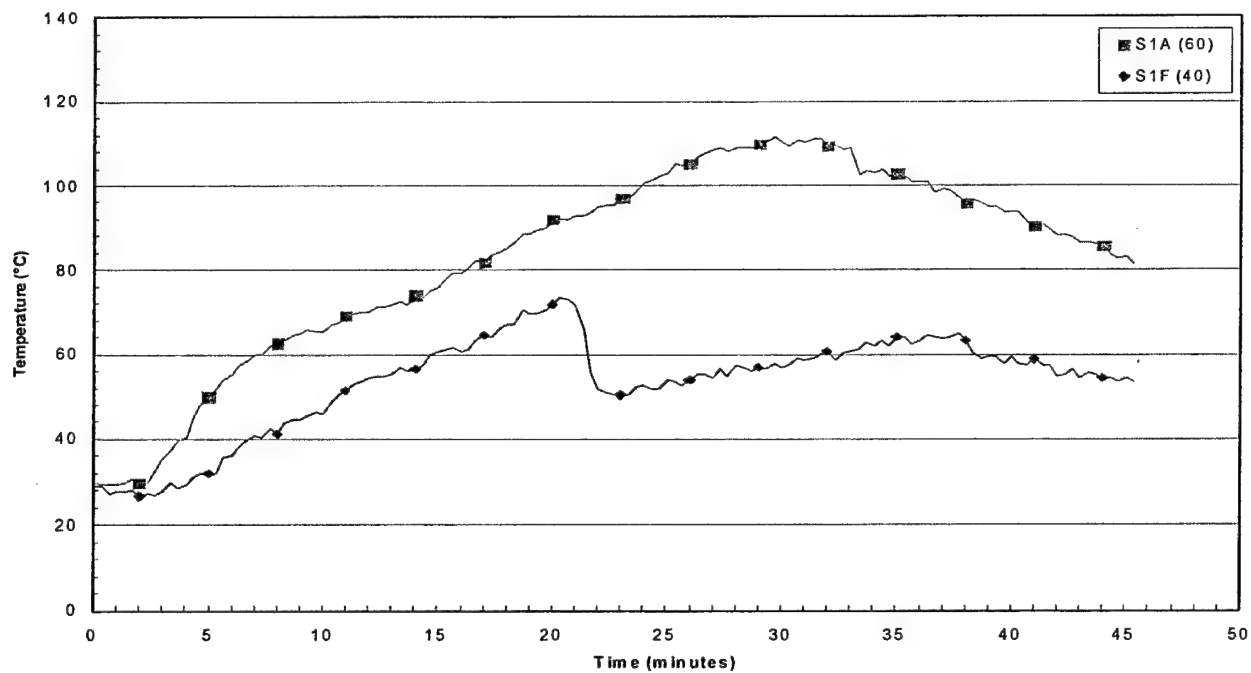
Figure 7. Temperature Profile, Panel #1

Figure 7 shows the panel surface time/temperature plots of the thermocouple pair for this panel. The upper trace is the temperature history on the aft, fireside, of panel 1. The lower plot is the temperature history on the forward, non-fire side, of the same panel. The lower trace reveals a 24°C (44 °F) drop in temperature between 21 and 23 minutes. At approximately the same time this drop in temperature occurred the calorimeter monitoring the forward side of this panel (upper trace in Figure 8) measured an increase in the total heat flux leaving the forward surface.

Prior to the 21-minute mark of the test, both forward and aft side, thermocouples display a nearly identical rate of increase at approximately 2 °C/min (3.7 °F/min) (Figure 7). From 23-30 minutes of the test, the aft side thermocouple continues to register a nearly identical 2 °C/min (3.7 °F/min) rate of rise while the forward side thermocouple registers a 0.4 °C/min (0.72 °F/min) rate of rise. The reduced rate of rise in forward surface temperature, beyond the 23-minute point, is further indication that a localized increase in convective cooling had occurred.

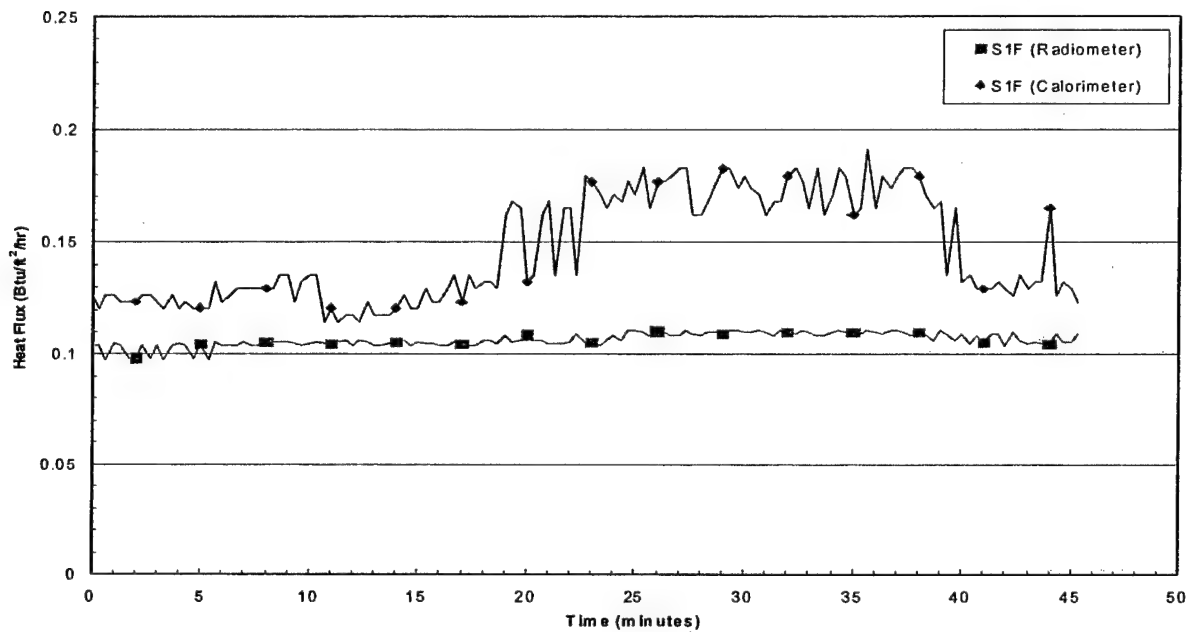
Figure 8. Heat Flux Profile, Panel #1

An increase in the convective heat transfer rate can be seen in the trace for calorimeter instrumentation (Figure 8) commencing at approximately 21 minutes. There are two possible explanations for this observed phenomena. The first possibility is that some fitting was opened, forward of the test bulkhead, which allowed ventilation currents to start. This would imply that either QAWTD 2-17-1, ventilation damper 2-15-1 or ventilation damper 2-15-2 was opened however the temperature profile for the forward compartment (Figure. 9) doesn't support this argument. In fact, according to written test records, QAWTD 2-17-1 and the two previously mentioned ventilation dampers remained closed throughout the entire test. Clear evidence of a change in these settings can be seen in Figure 9 when both high and low compartment temperature profiles drop precipitously at approximately 39 minutes. The reason for this sudden drop in temperature was opening of QAWTD door 2-17-1 and ventilation damper 2-15-1, by a member of the Safety team, to facilitate post-test cooling of the area. Another possible explanation for the increase in convective heat flux observed is that localized eddy currents began to dominate and convective cooling increased.

The upper data plot in Figure 8 is the sum of radiant and convective flux. The thermally driven velocity profile just described would have increased the convective heat transfer coefficient (h) across the forward surface of test panel 1. The increase in (h) would have increased the magnitude of the convective heat flux measured on the forward surface of this panel. This is exactly what is shown implicitly by the raw data and explicitly when equation 4 is applied to these two data traces.

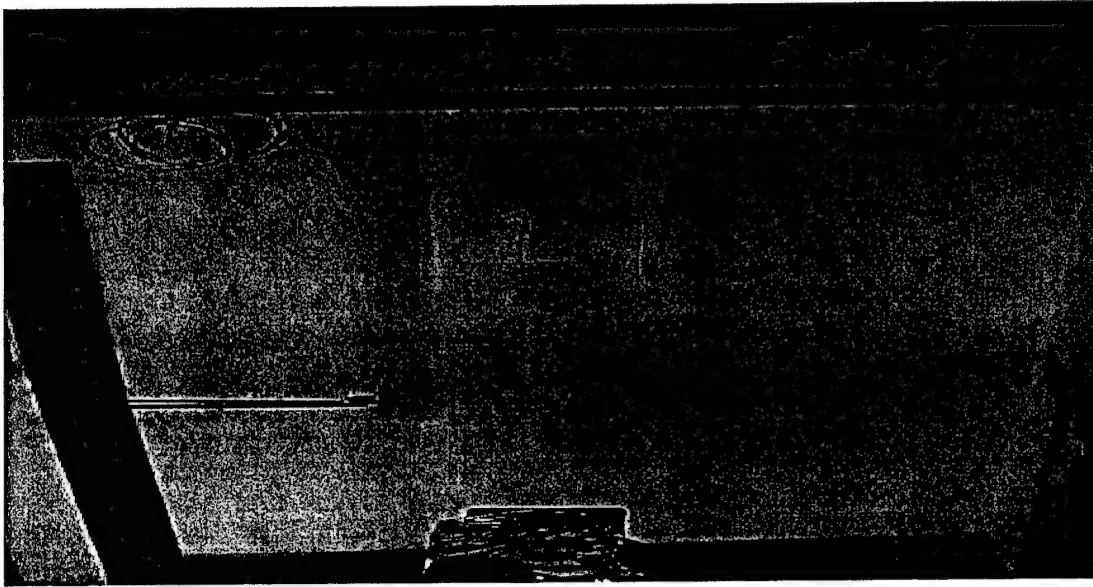
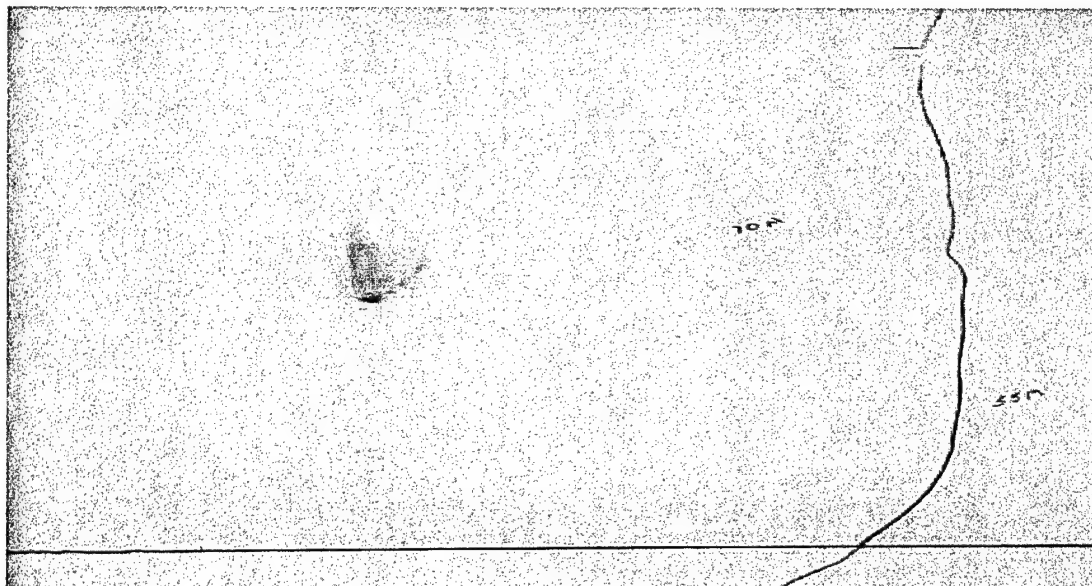
Figures 10-12 are before and after photographs of the product *Temp Coat*. This coating was applied to the forward side of panel 1. Other than one area of discoloration, this coating showed no physical reaction to the test fire. The area of discoloration, seen close-up in Figure 12 occurred near the 55 mil and 70 mil thickness. The elliptical structure rising from the top of a nearly circular point of discoloration seems to indicate a surface stain resulting from a point source of smoldering combustion.

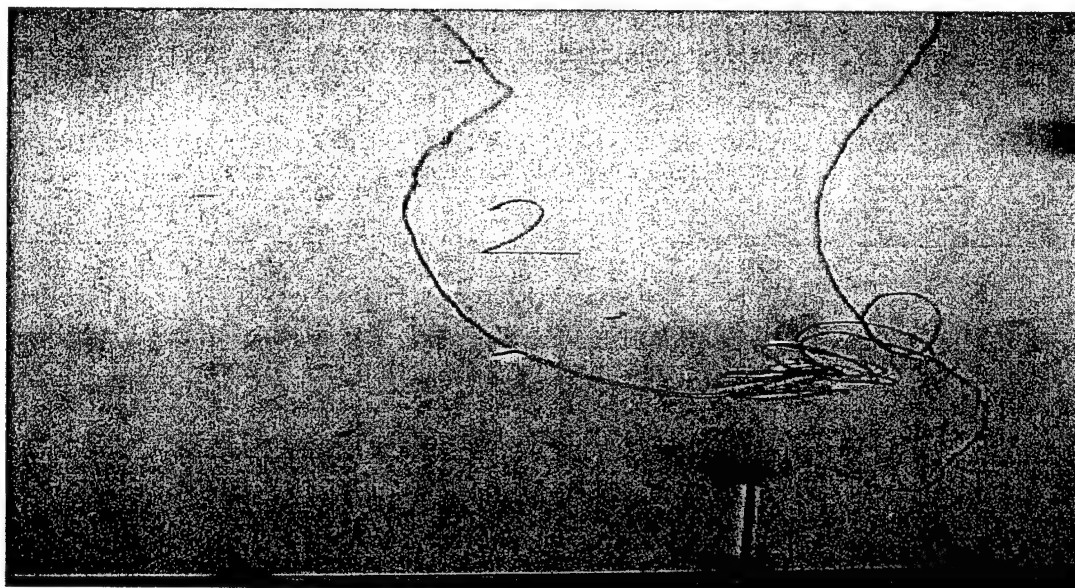
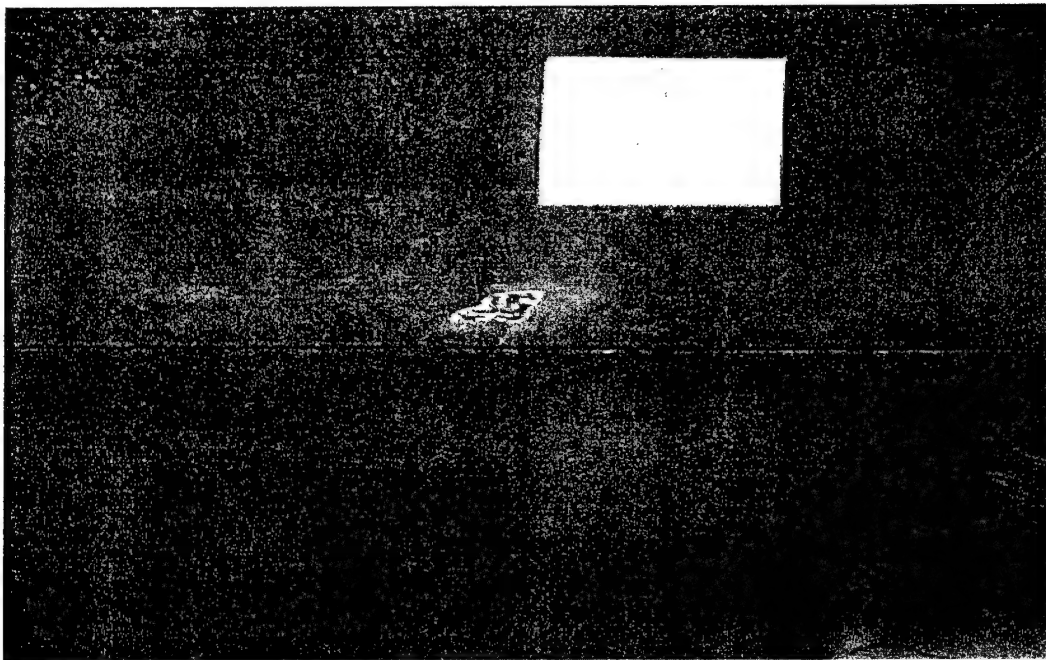
Figures 13-15 are before and after photographs of the coating *Fire Barrier-520*. The test panel was located approximately 4.6 m (15 ft), at roughly 30°, to the port side the ALPHA fire. Figure 14 show the coating produced very little blistering and no cracking. The coating did not intumesce. Considering that the spatial separation between panel 2, panel 1 and the large ALPHA

fire were similar, it seems logical to conclude the *Fire Barrier 520* coating is capable of sustaining higher levels of radiant insult than the fire barrier 1 coating before bubbling.

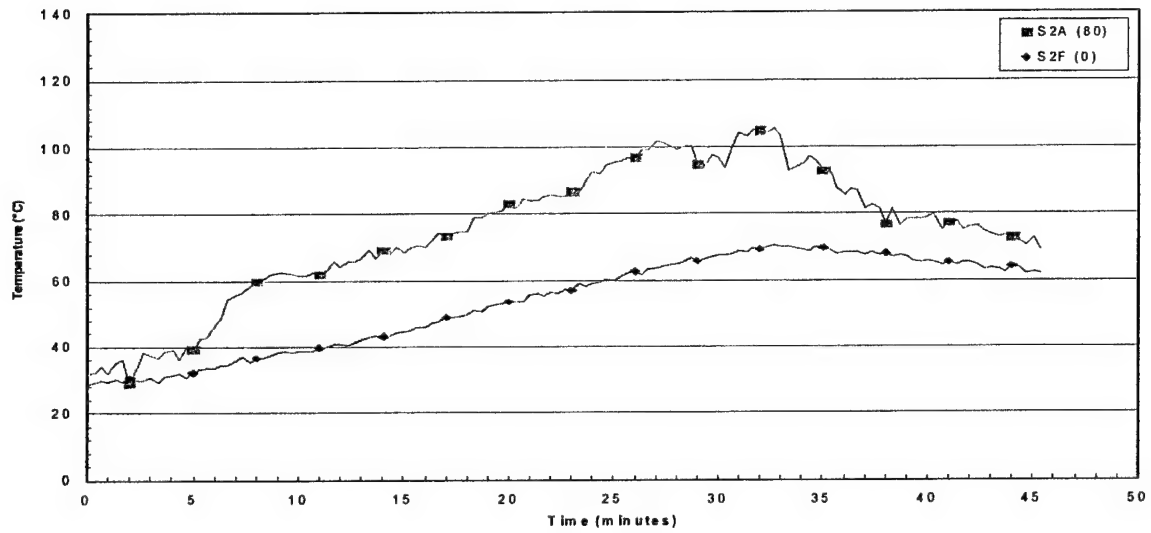
Figure 16. Temperature Profile Panel #2

Figure 16 shows the time/temperature plot of the thermocouple pair for this panel. The temperature differential, between forward and aft thermocouple, was 23 °C (73 °F) at 10 minutes and 38°C (100 °F) at 27 minutes. The aft surface temperature maintained a consistent 2.4 °C/min (4.3 °F/min) rate of rise from approximately 10 minutes through 27 minutes. The forward surface temperature maintained an almost uniform 1.5 °C/min (2.7 °F/min) rate of rise for the same period of time.

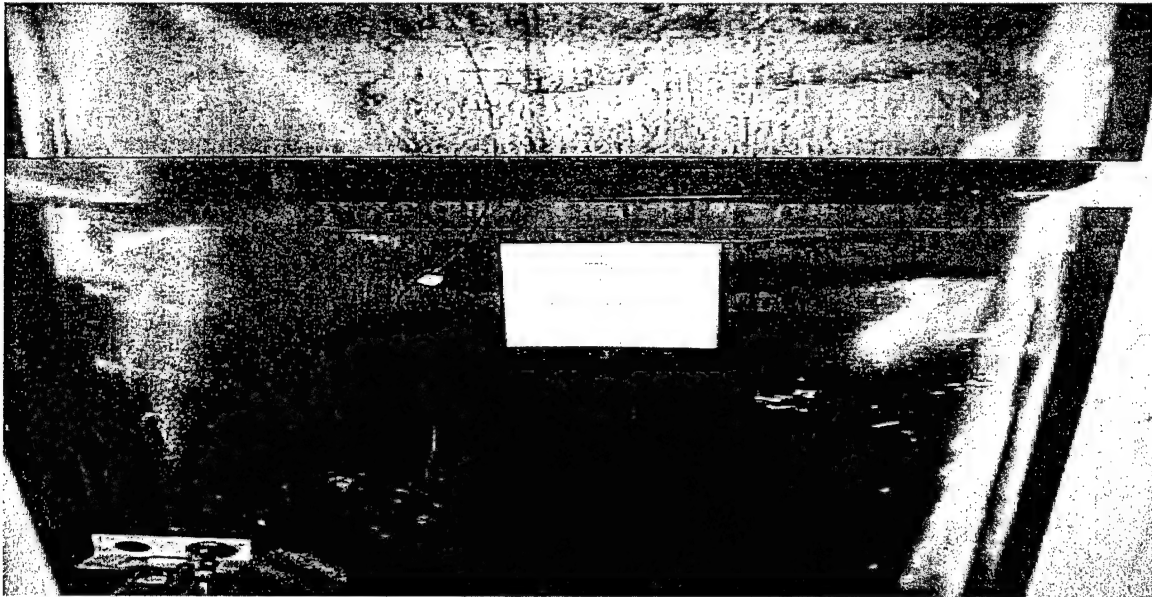
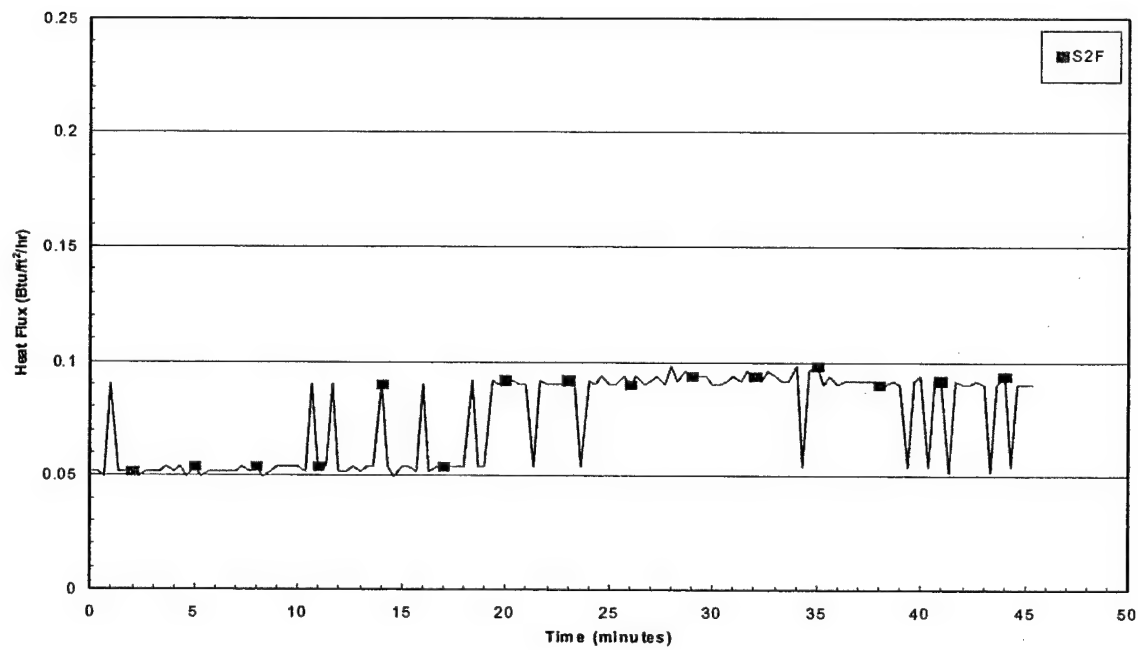
The forward surface of this panel was uncoated. Examination of Figures. 17 and 18 show there was no physical change in condition of this surface. Figure 19 is a plot of radiant heat flux measured from the forward surface of this panel. The erratic nature of the trace, commencing at about 13 minutes, seems to indicate development of "hot spots" and a non-uniform temperature distribution across the untreated surface. This would have been the result of non-uniform application thickness of the *Fire Barrier-520* coating on the opposite side of the panel. The increase in radiant flux measured at approximately 20 minutes, (0.052 Btu/ft²/hr) to (0.092 Btu/ft²/hr), looks significant when taken by itself. However, the maximum measured radiant flux for this panel remained below the maximum radiant flux (0.105 Btu.ft²/hr) measured on the forward surface of panel 1. This seems to indicate that a 90 mil thickness of *Fire Barrier-520* will provide resistance to conductive heat transfer exceeding that of a combined 65 mil thickness of *Fire Barrier-1* and 50 mil thickness of *Temp-Coat*.

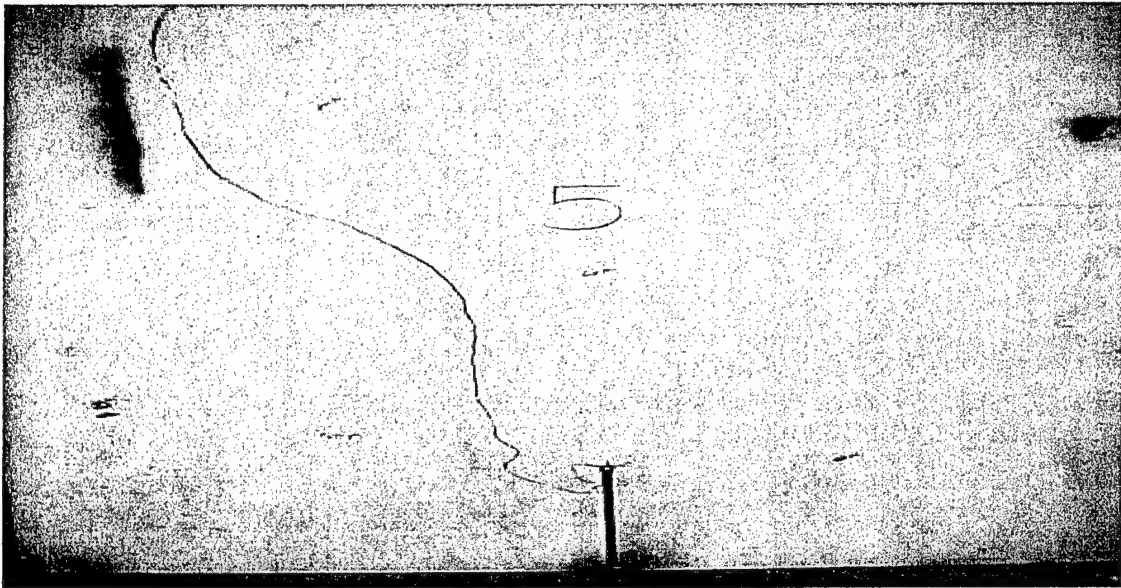
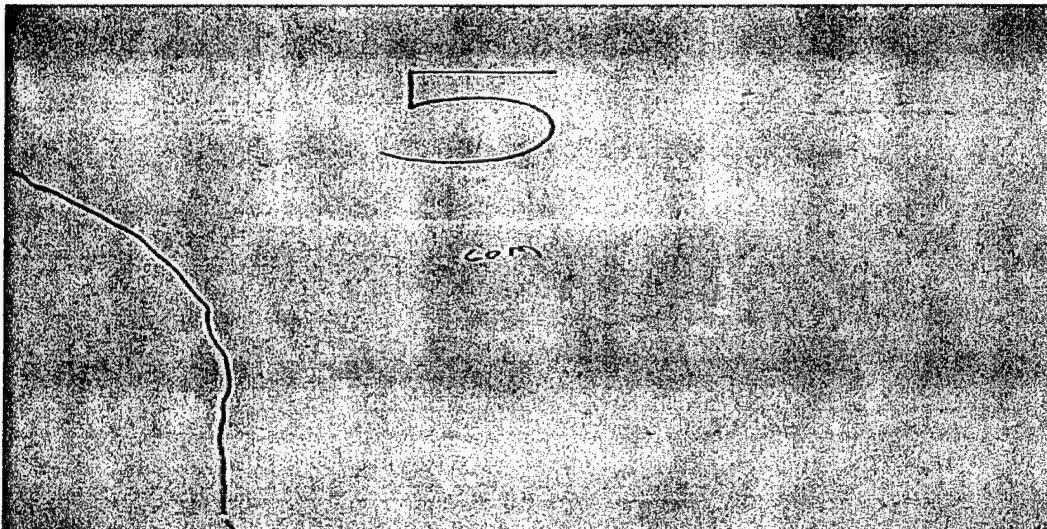
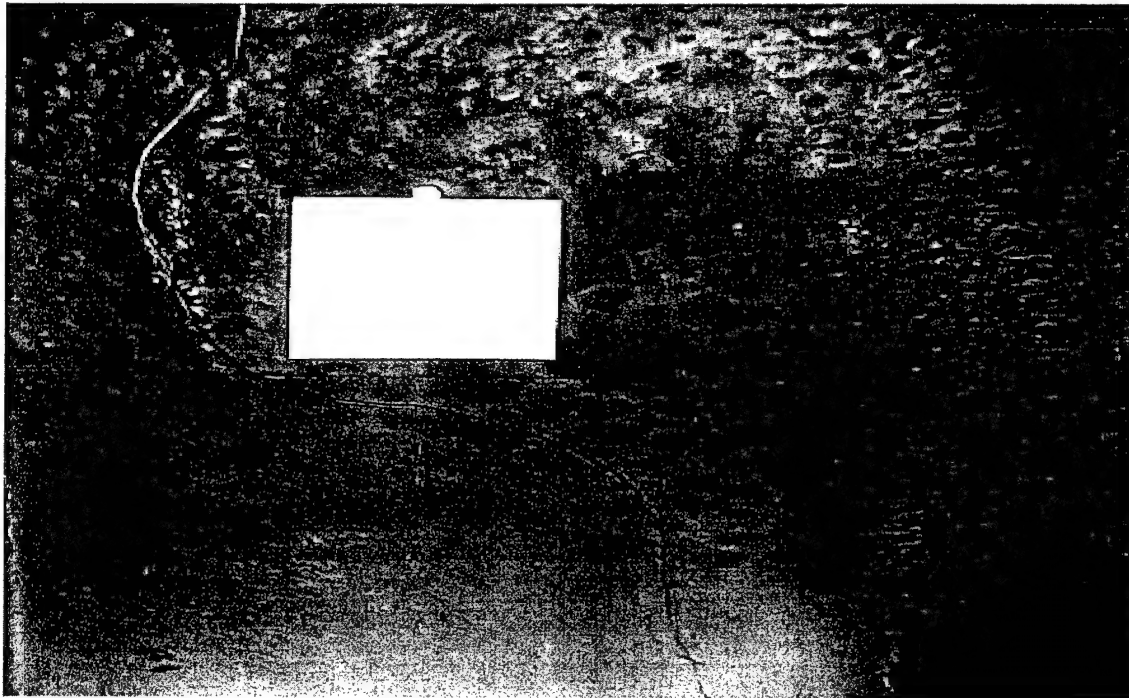
Figures 20-24 are before and after pictures of the coating, *Fire Barrier-2*, applied to the aft side of panel 5. This panel was directly in front of the BRAVO pool fire. The coating would have been subjected to direct impingement of the flame throughout the entire time the heptane pool was burning. A small area of this coating, directly above the fire pan, showed some degree of intumescent response but not of the scope and uniformity that would have been expected. The coating surface was a mixture of hardened crust, blisters and a shallow, intumescent char. The dominant response of the coating on this panel was blistering. There was some post test indication this coating suffered minor cracking during the fire.

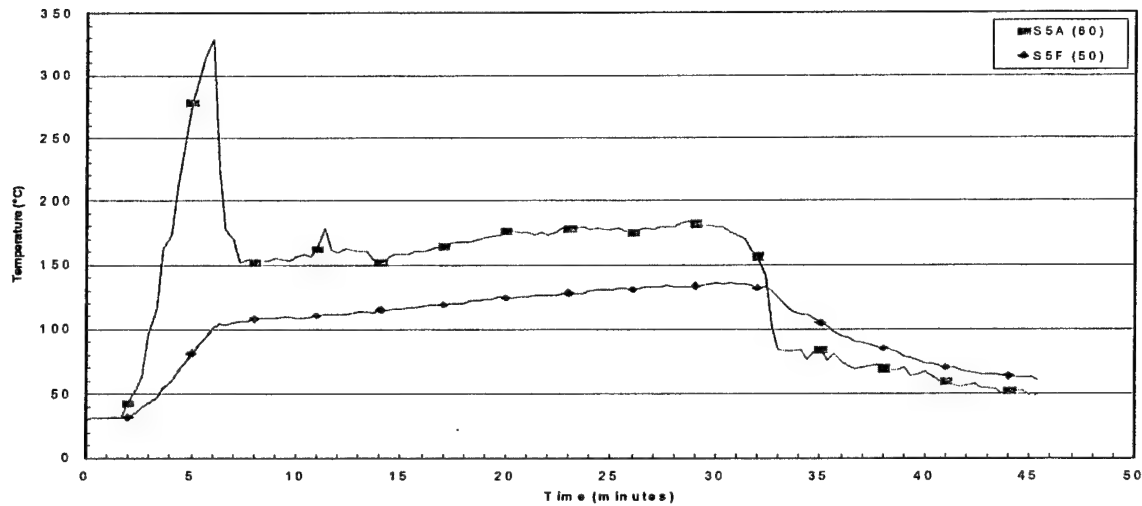
Figure 25. Temperature Profile Panel #5

Figure 25 shows the fireside bulkhead thermocouple rising rapidly from an ambient temperature of 31 °C (88 °F) to a maximum of 330 °C (594 °F) and then back to a temperature of approximately 153 °C (307 °F) in a period of approximately 6 minutes. Based on post test inspection of the coating it has been determined that the initial rate of temperature rise due to the 5 gallon heptane pool fire, approximately 75 °C/min (126 °F/min), was insufficient to activate a large scale intumescent response across the aft surface of this particular panel.

There are two possible explanations for the rapid rise and fall of the fire side surface thermocouple temperature profile (Figure 25). The first explanation is localized burning of evolved organic vapors. The second explanation is a fluctuating burn rate of the 30 cm x 76 cm (12 in. x 30 in.) heptane pool. The current understanding is that fire compartment ventilation has a measurable impact on pool burning rates, heat release rates and species production (Refs. (11) - (12)). An increase in products of incomplete combustion (smoke, CO) is some indication that there was a decrease in ventilation to the fire.

After the brief temperature "spike," the forward and aft side thermocouple exhibited a nearly identical rate of rise, 1.3⁰F/min), up to the 29 minute point in the test. The temperature

differential between aft and forward surface of this panel remained a nearly constant 49⁰C (120⁰F) from 7-29 minutes of the test.

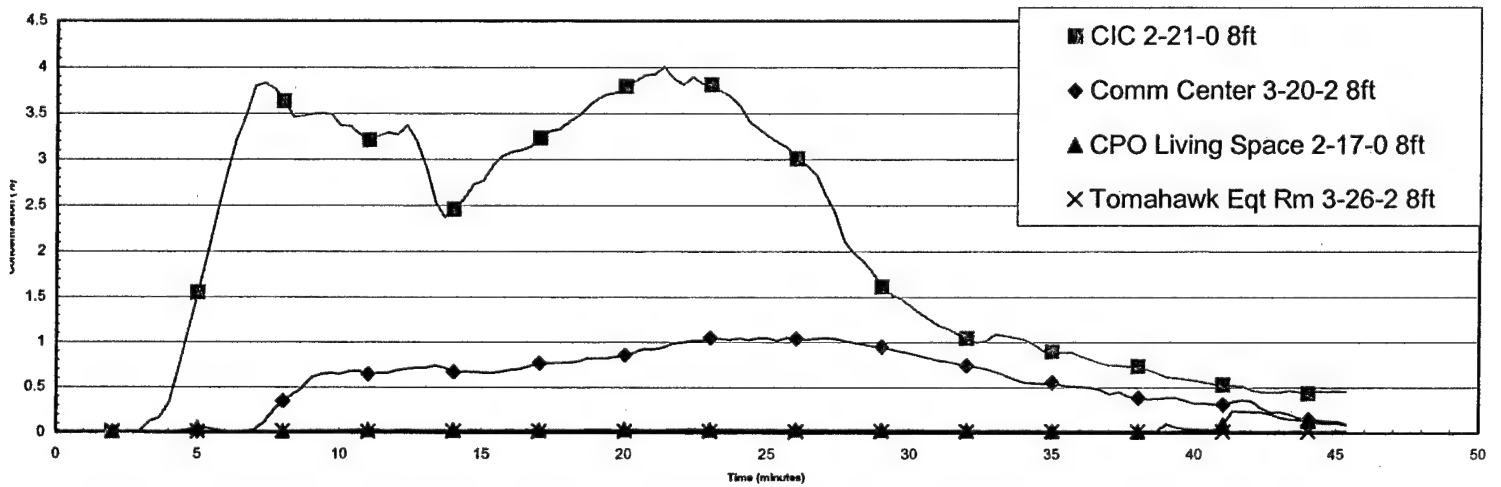
Figure 26. CO Concentration Profiles

For the test being discussed, a cyclic variation in fire compartment ventilation seems to be indicated by the time history of compartment CO concentration. The top trace of Figure 26 shows a rise and fall of CO concentration high in the fire compartment. A decrease in ventilation also seems to be indicated by a decrease in burning rate of the heptane pool, reflected in the top trace of Figure 27, and a decrease in burning rate of the combined ALPHA/BRAVO fire as seen in the upper thermocouple trace of Figure 28. The upper thermocouple trace in Figure 27 is data collected approximately 152 cm (60") above the seat of the combined ALPHA/BRAVO fire at frame 20.

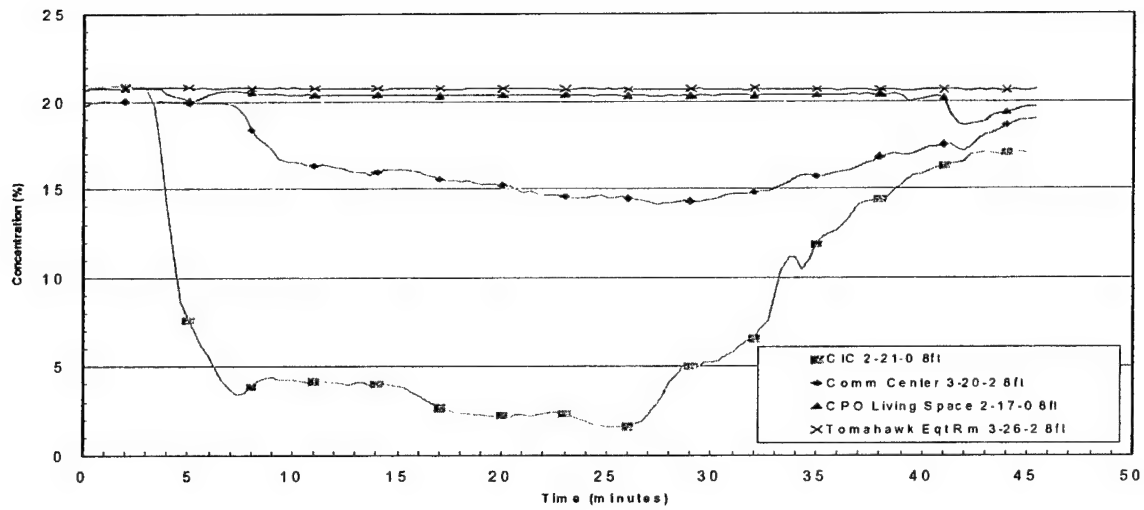
Figure 29. Oxygen Concentration Profiles

Further indication of a ventilation restricted burn can be seen in the bottom two traces of Figure 29. The sampling locations were 2.5 m (96") above the fire compartment deck and approximately 0.3 m (12") below the seats of the test fires. There were two large penetrations in the deck of the fire compartment immediately aft of the heptane pool. These large penetrations would have allowed free communication of the atmospheres between compartments 2-17-0 and 3-15-0. The oxygen measurement attributed to compartment 3-20-2 was, physically, directly below and between the seats of both test fires. The oxygen profile for the 3-20-2 location would have been, due to physical proximity alone, a close approximation of the available oxygen at the seats of these fires.

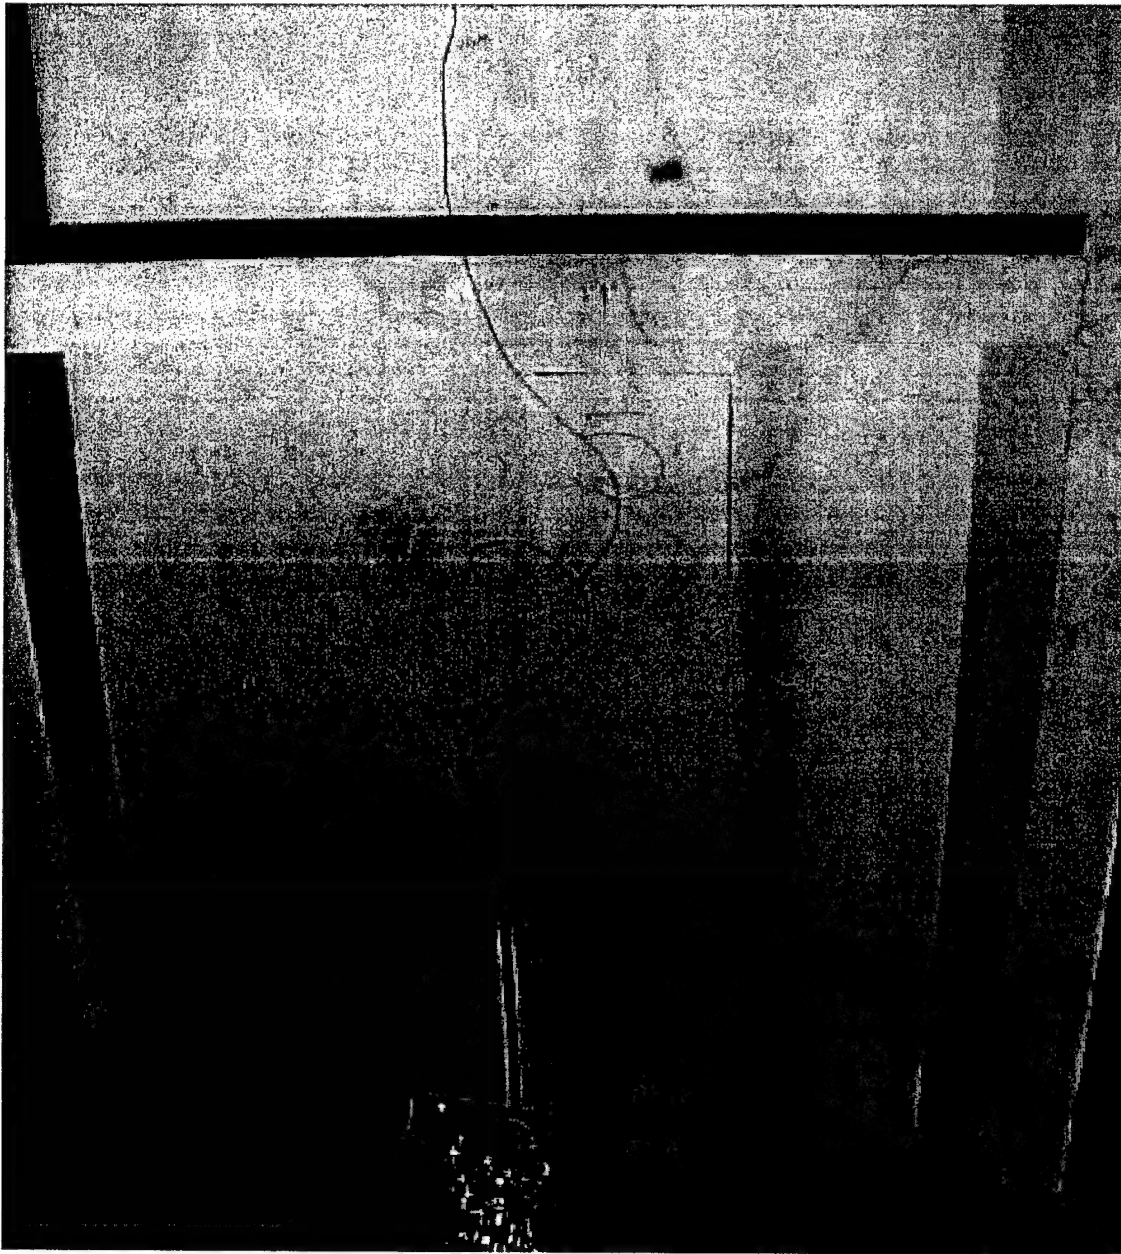
Figure 30 and 31 are before and after pictures of the *Temp Coat* layer applied to the forward surface of this panel. Examination of Figure 31 will reveal a minor discoloration to a small area of this surface. Post-test inspection indicated this discoloration is super imposed atop a weld used to support the aft surface thermocouple. Existence of the weld "short circuited" the *Fire Barrier 520* coating by allowing a direct path for conduction of a heat to the forward side of the panel. With this minor exception, there was no visible impact from the heptane pool to the *Temp Coat* layer.

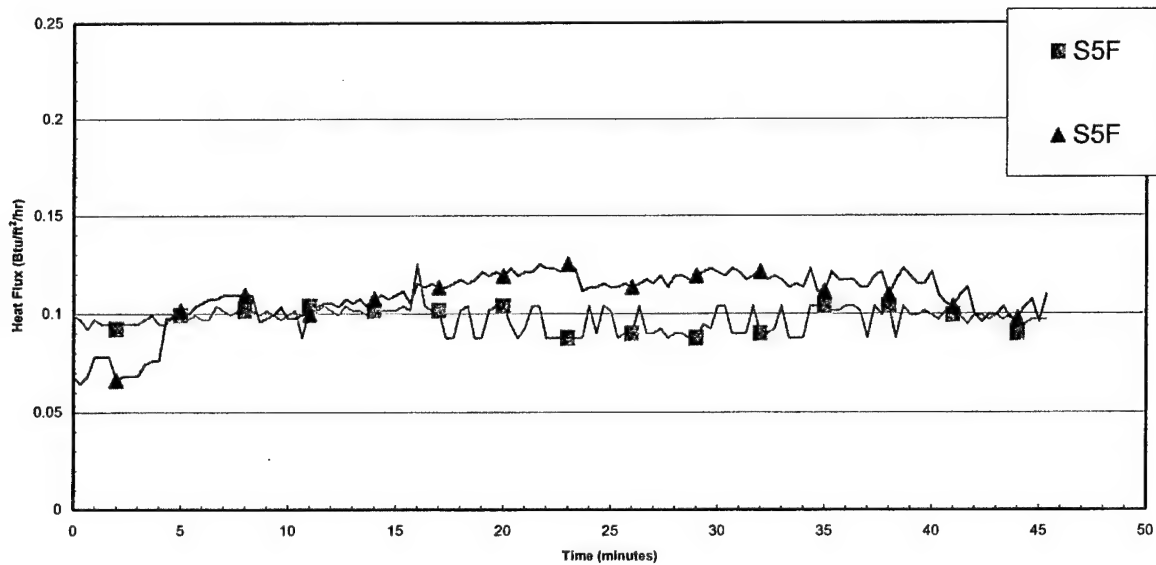
Figure 32. Heat Flux Profiles Panel #5

Figure 32 displays measurements of radiant and total heat flux from the forward surface of test panel 5. The erratic 12% fluctuation in the radiative flux component, lower trace, seems to correspond with the previously discussed increase in free convection.

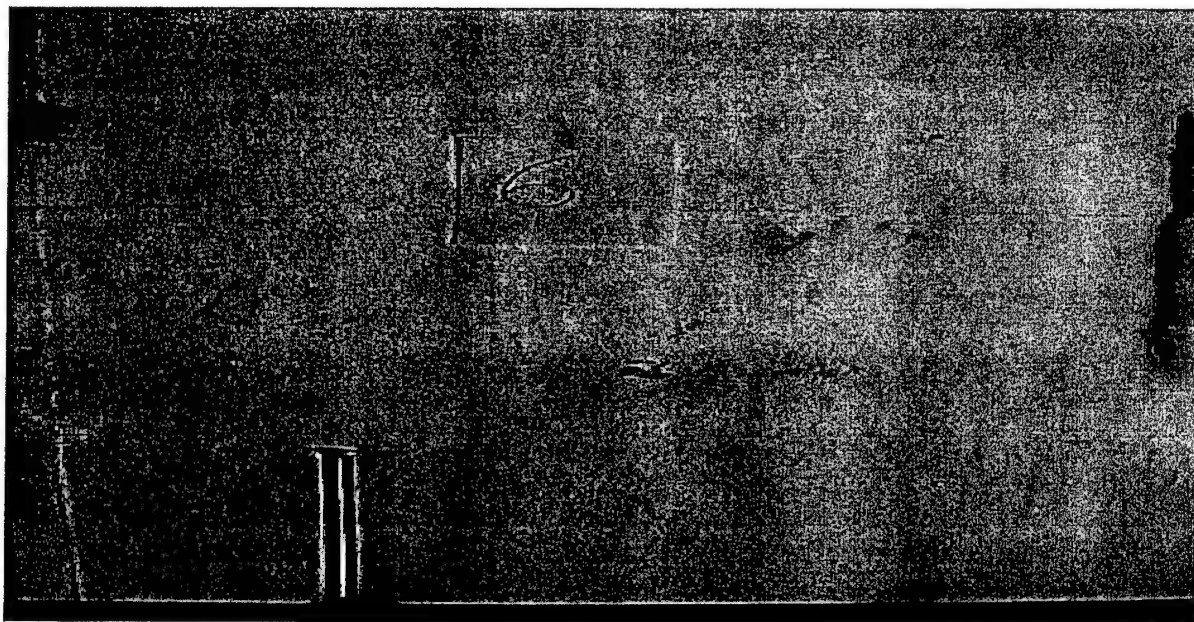
Figures 33-35 are before and after pictures of the coating *Fire Barrier-2*. As seen in the lower left-hand corner of Figure 34, this panel was immediately adjacent to the 5-gallon heptane pool fire. The entire surface of the coating, from deck to overhead, blistered very heavily. There was no indication of any cracking.

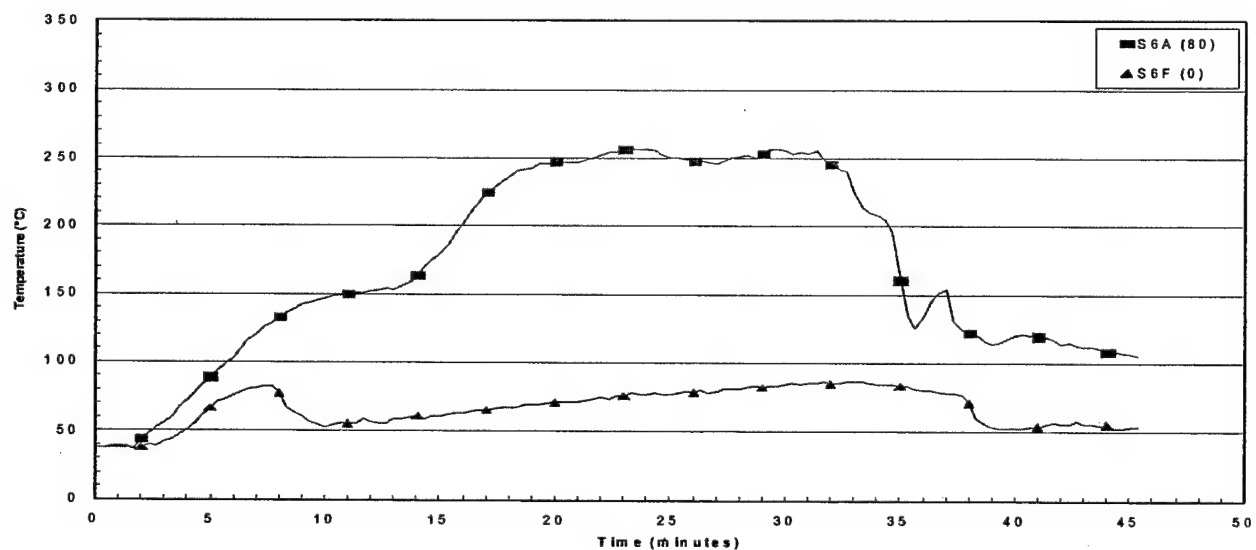
Figure 36. Temperature Profile, Panel #6

The forward side thermocouple (Figure 36) exhibits an initial rise of $6.25\text{ }^{\circ}\text{C}/\text{min}$ ($11.25\text{ }^{\circ}\text{F}/\text{min}$), to a maximum of $84\text{ }^{\circ}\text{C}$ ($183\text{ }^{\circ}\text{F}$) prior to the $31\text{ }^{\circ}\text{C}$ ($88\text{ }^{\circ}\text{F}$) drop in temperature at 8 minutes. After this drop the forward side thermocouple exhibits a consistent $1.5\text{ }^{\circ}\text{C}/\text{min}$ ($2.7\text{ }^{\circ}\text{F}/\text{min}$) rate of rise through the duration of the test. The maximum temperature differential across this bulkhead is approximately $178\text{ }^{\circ}\text{C}$ ($352\text{ }^{\circ}\text{F}$), occurring at 20 minutes into the test.

The temperature differential across this test panel (Figure 36) became significant at approximately 8 minutes into the test when the forward side thermocouple registered a $30\text{ }^{\circ}\text{C}$ ($86\text{ }^{\circ}\text{F}$) drop in temperature. Post test inspection of the panel determined that the fireside thermocouple was within the blistered region. This can be seen by close inspection of the bottom left hand corner of Figure 34. At the same time the forward surface thermocouple recorded the temperature drop, the level of radiant heat flux leaving the forward surface was recorded at a fairly stable ($0.082\text{ Btu}/\text{ft}^2/\text{hr}$) level (Figure 37). Considering the radiant flux leaving the forward side of the panel was stable during the recorded drop in temperature, it seems unlikely that loss of energy due to radiation would be the source of the observed temperature drop. In addition, the drop in temperature cannot be attributed to the previously discussed increase in free convection because the two events are separated by at least 12 minutes. The only remaining, logical, conclusion as to what influenced the measured temperature decrease, is blistering of the aft side coating.

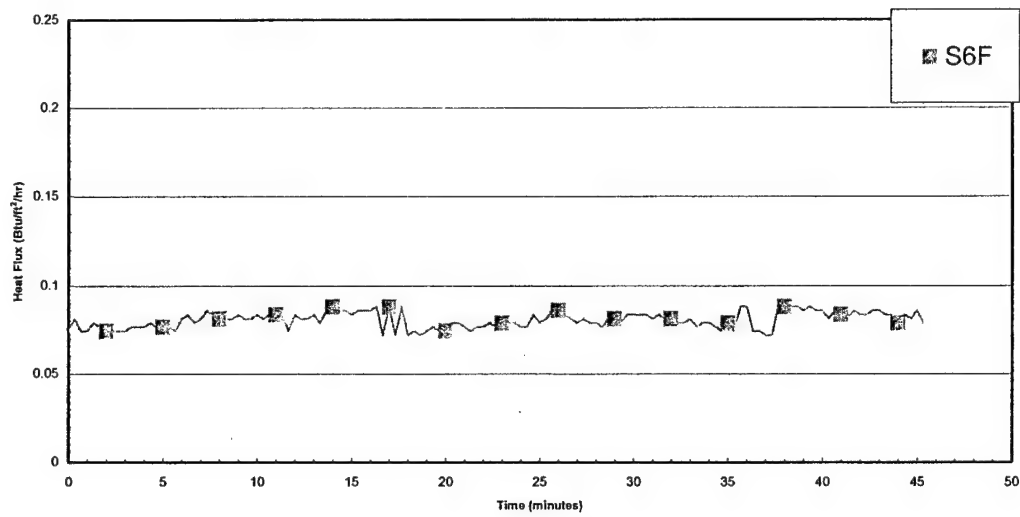
Figure 37. Heat Flux Profile, Pane #6

Btu/ft²/hr level (Fig. 37) considering the radiant flux leaving the forward side of the pane was stable during the recorded drop in temperature, it seems unlikely that loss of energy due to radiation would be the source of the observed temperature drop. In addition the drop in temperature can not be attributed to the previously discussed increase in free convection because the two events are

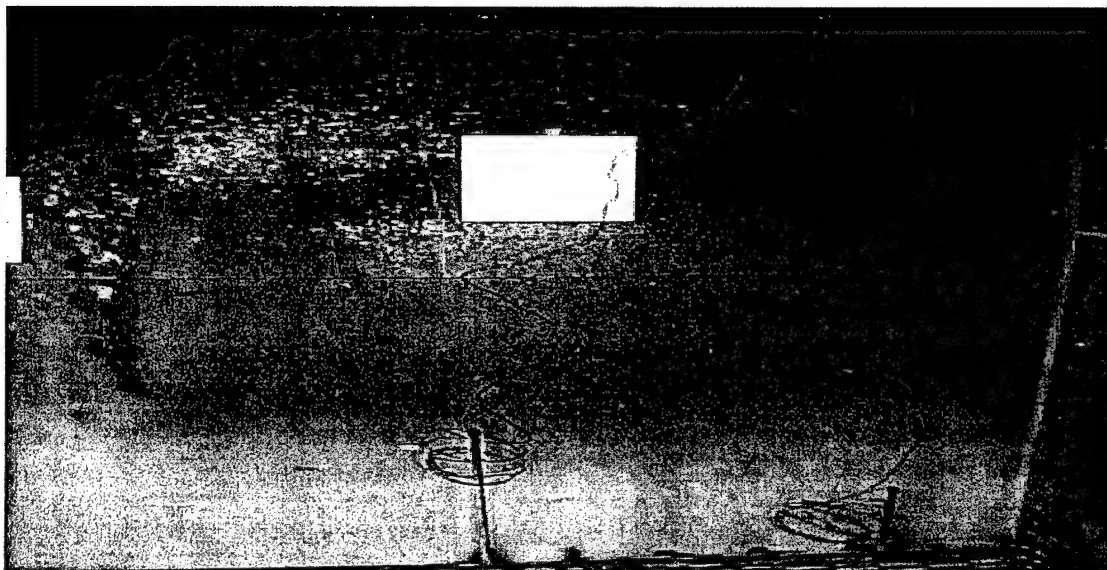
Figures 40-42 are before and after pictures of the coating *Fire Barrier-2*. This panel was located on the far starboard side of the test compartment. This panel was only subjected to a radiant insult due to its physical location. The coating, from 5' above the deck to the overhead, blistered very heavily. The coating exhibited no reaction below the 5' level. The post test inspection showed no indication the blistered coating was cracked.

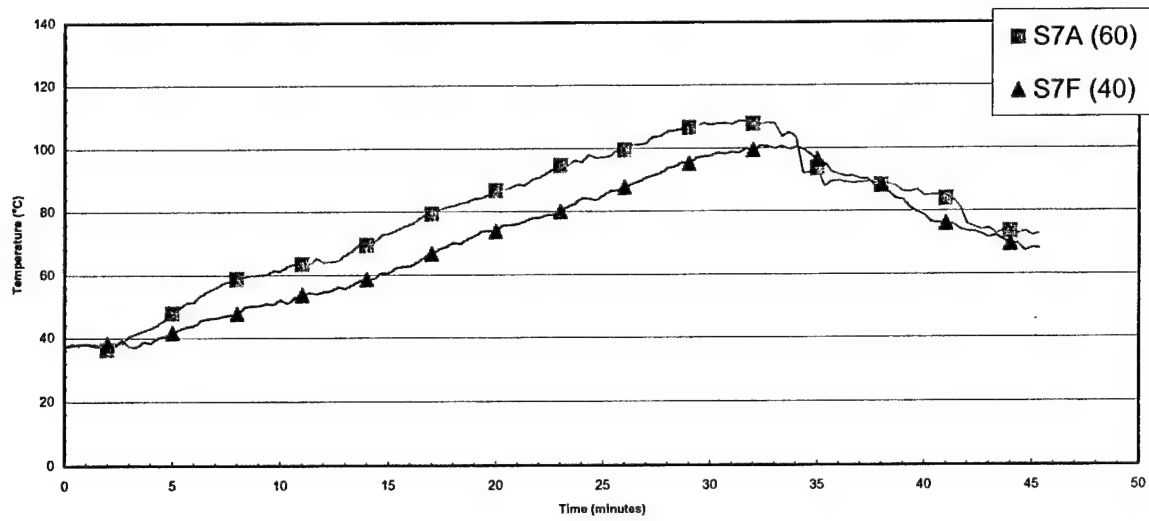
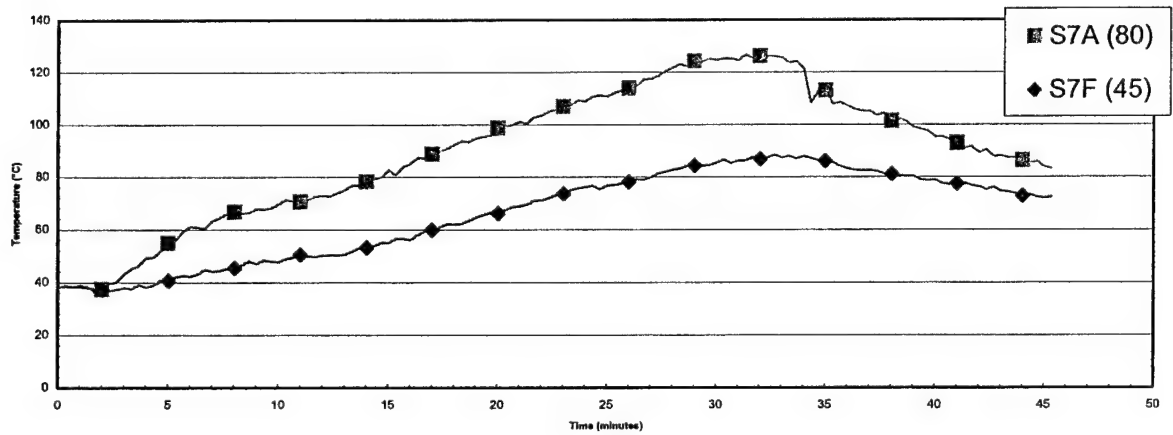
The bottom traces of Figure 43 and Figure 44 show there was little apparent benefit to application of the Temp Coat product. The maximum surface temperatures on the Temp Coat treated forward side of panel 7 (Figures 43 and 44), were not significantly different than those

measured on the bare, forward side of panel 6 (Figure 36). No correlation can be drawn between the measurements made at 66 inches above the deck on the forward side of panel 7 (Figure 45) and those made at 23 inches above the deck on the forward side of panel 6 (Figure 36).

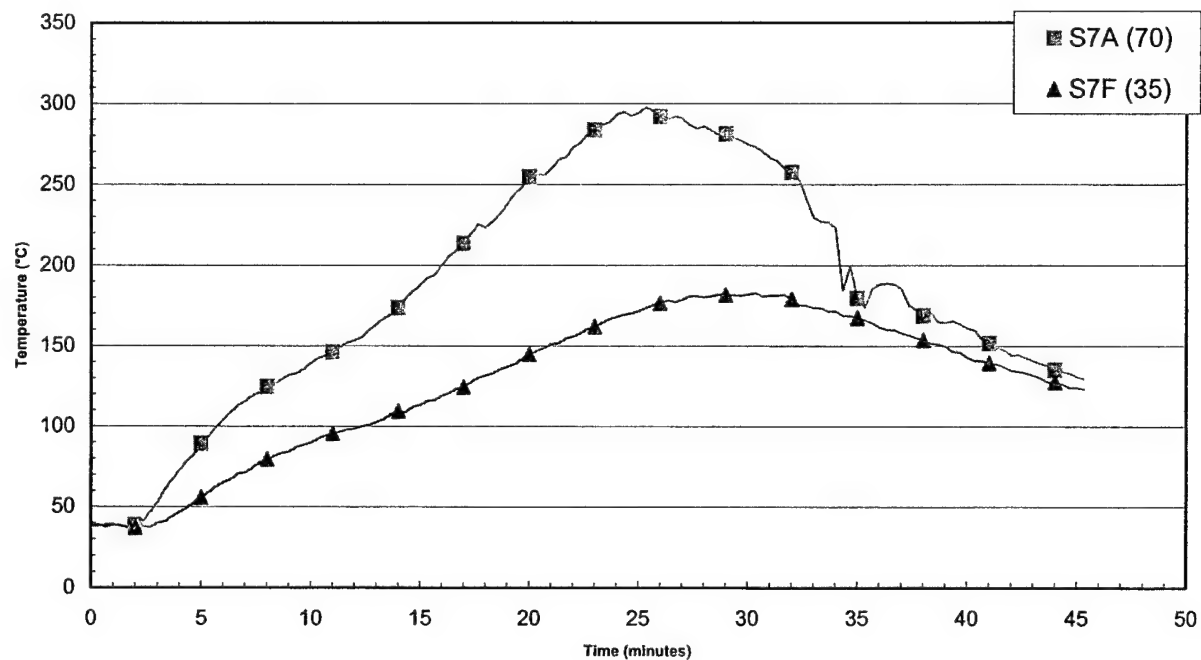
Figure 45. Temperature Profile, Panel #7, 66" Above Deck 70 Mil Fire Barrier-2, Vs. 35 Mil Temperature Coat

Figure 45, measured at 66" above the deck, shows the fireside thermocouple temperature rise being 10.9 °C/min (19.6 °F/min) while the forward side rise is 6 °C/min (10.8 °F/min). The temperature differentials were 33 °C (91 °F) at 5 minutes, 75 °C (167 °F) at 15 minutes and 126 °C (259 °F) at 24 minutes.
